CHRISTMAS OFFERINGS

Recently in the emergency department: chest x-ray of a repeatedly resuscitated object

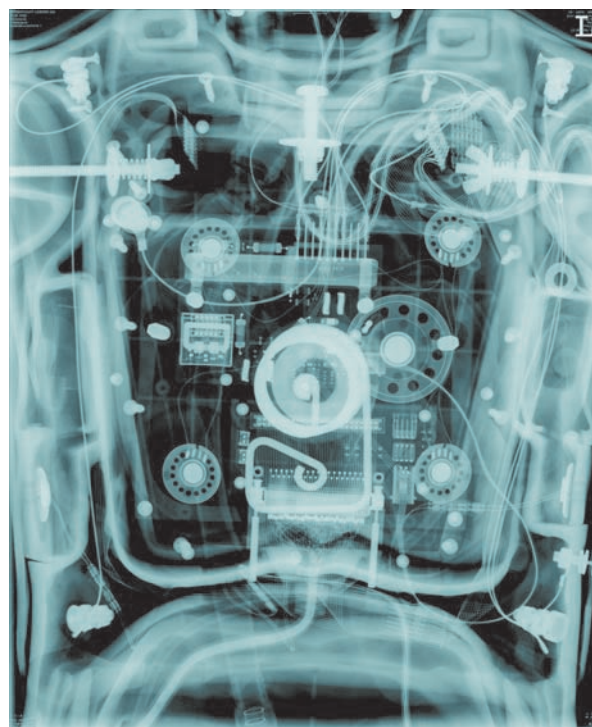
“Kelly Laerdal”, age unknown, but repeatedly resuscitated, was scheduled for a chest x-ray to investigate the metallic contents of the thorax, with the aim of understanding why resuscitation manikins might differ in their susceptibility to electromagnetic interference in electrocardiogram recording.¹

Besides some minor electronic components, the image shows a prominent cardiac massage pressure point, gives a hint of shoulder joint junctions, and shows exactly where the auscultation regions (covered by loudspeakers) are located — a “must know” for every advanced cardiac life support student.
